PENNSYLVANIA  
**LYMAN RUN DAM**

NDS ID NO. PA-29  
DER ID NO. 53-49

PHASE I INSPECTION REPORT  
NATIONAL DAM INSPECTION PROGRAM

NAME OF DAM: Lyman Run Dam  
STATE LOCATED: Pennsylvania  
COUNTY LOCATED: Potter  
STREAM: Lyman Run  
DATE OF INSPECTION: June 27 and 28, 1979

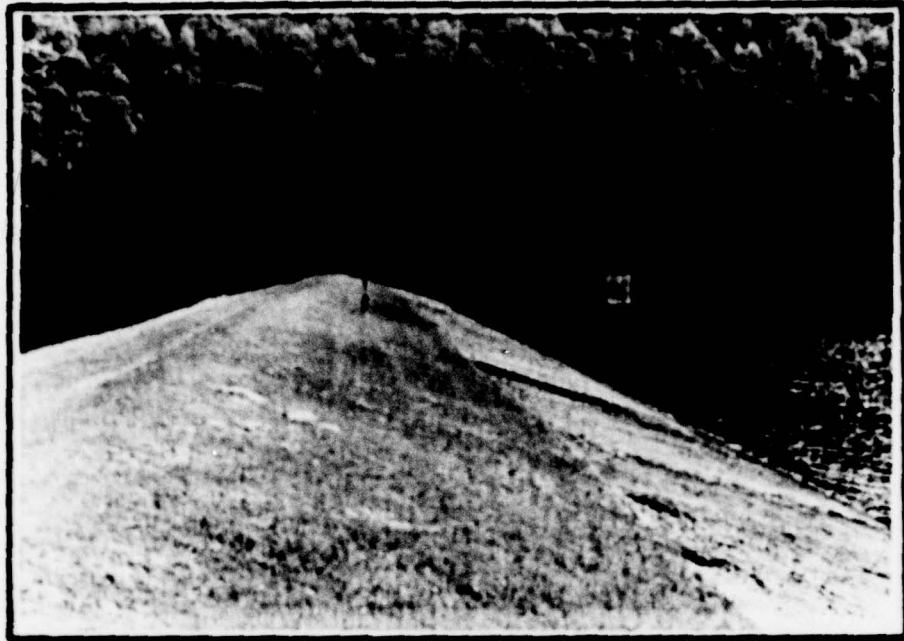
Overview of upstream slope - Note drain line  
control structure in reservoir.

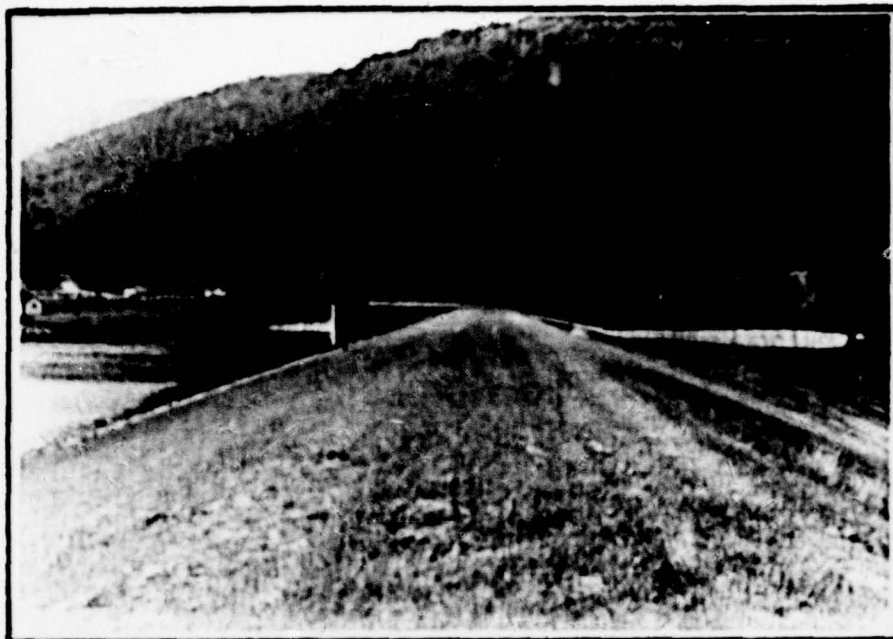
Crest of dam looking toward spillway (left abutment).

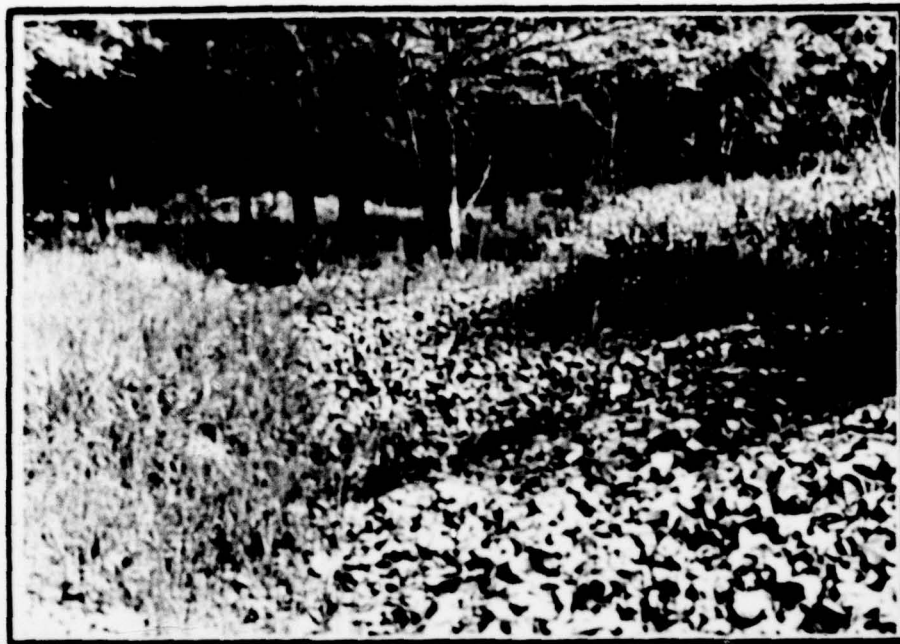
Rock underdrain beyond toe of dam.

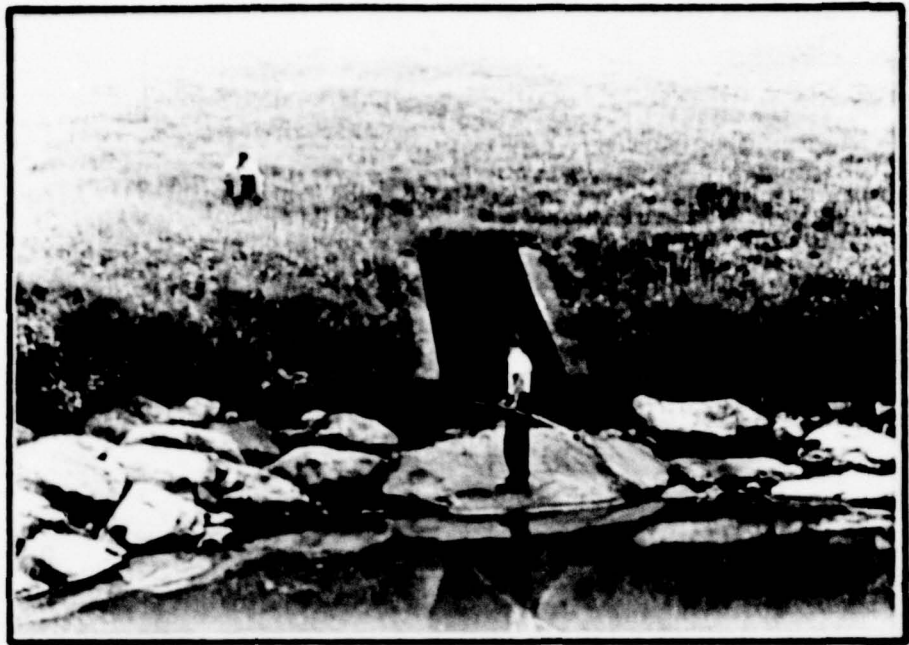
Discharge end of outlet works.

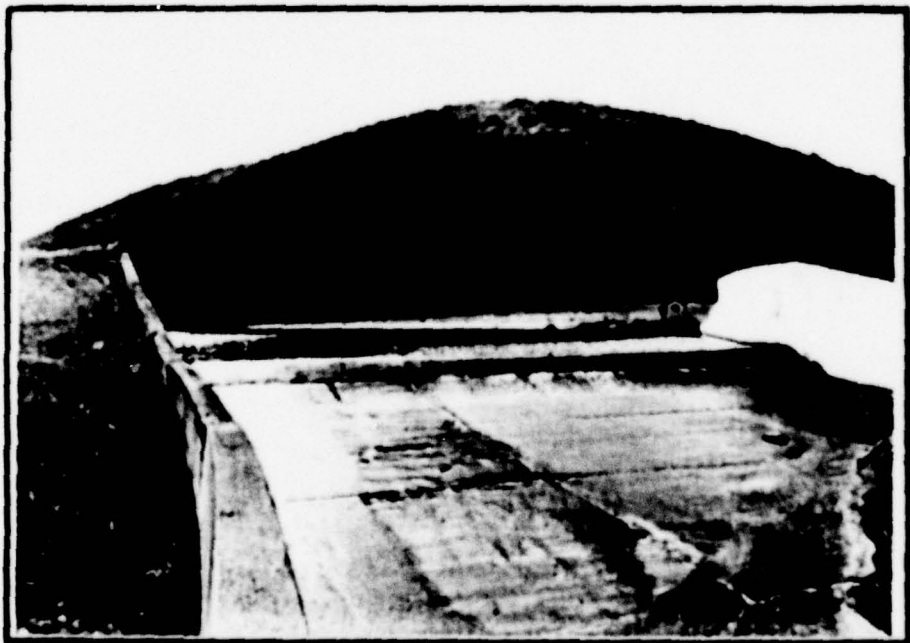
Spillway weir.

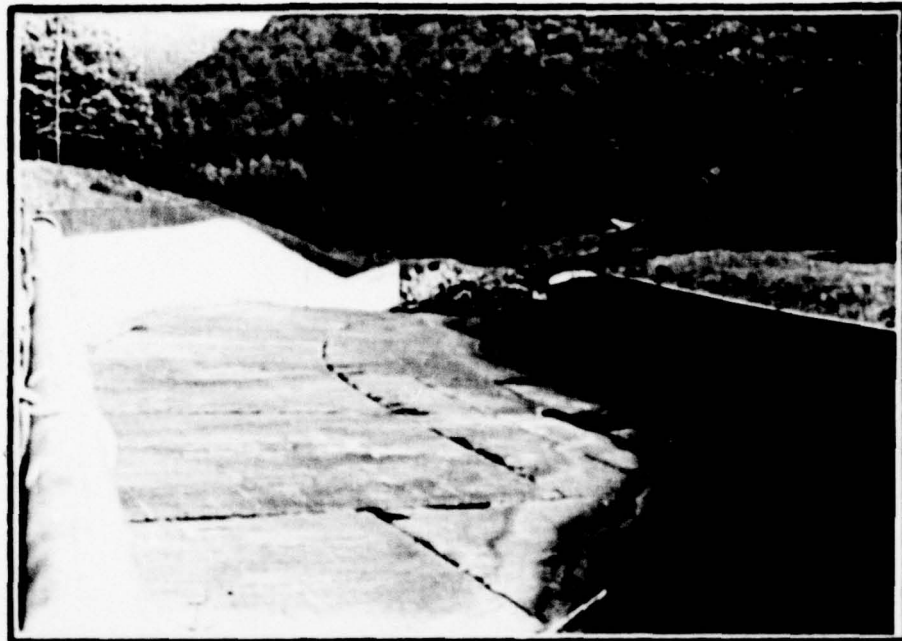
Emergency spillway.

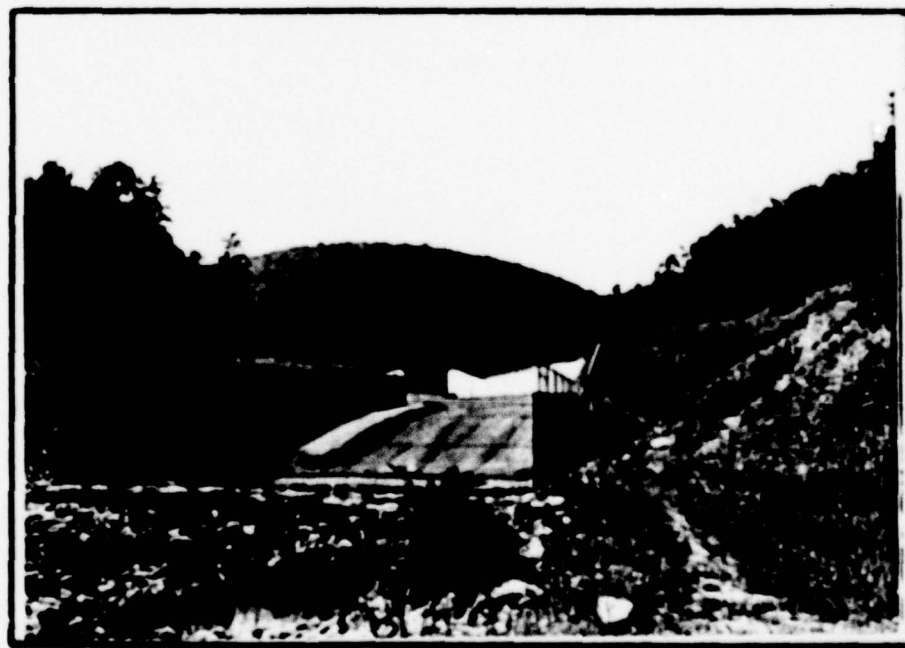
c. Appurtenant Structures. The reservoir level at the time of inspection was 1635.1. The emergency spillway and facilities appeared to be in good condition. The concrete weir appeared to be in good condition. In addition, the spillway exit channel retaining walls appeared to be in good condition and stable. Some cracks have developed in the bottom slab of the spillway exit channel.

Emergency spillway and stilling basin.

3. The cracks in the bottom of the spillway exit channel should be repaired and sealed.
